## Appendix 2 Tree Work Recommendations

**Client:** Shrewsbury Town Council  
**Site:** Castlewalk Park, Underdale Road, Shrewsbury

## Llanerch Arboriculture

**Surveyor:** David Woodhouse  
**Report Date:** 7th October 2025

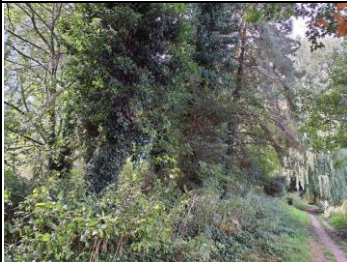
| Ref. | Species | Location | Survey Notes | Work Recommendations | Priority | Photo | Photo |
|---|---|---|---|---|---|---|---|
| G009 | Cherry<br>( <i>Prunus sp. 'Cherry'</i> )<br>Sycamore<br>( <i>Acer pseudoplatanus</i> )<br>Common ash<br>( <i>Fraxinus excelsior</i> )<br>Red oak<br>( <i>Quercus rubra</i> )<br>Field maple<br>( <i>Acer campestre</i> )<br>Italian alder<br>( <i>Alnus cordata</i> )<br>Scots pine<br>( <i>Pinus sylvestris</i> ) | Long arching group centrally located, bordering the play area | Good mixed grouping. Some trees are multi-stemmed. Much of area has low levels of or no access, but there are distinct cut through paths.<br>Ash trees appear reasonable in health.<br>Dead branches in group are over low risk areas.<br>Ivy on trees barely impedes inspection, with the habitat benefit being significant.<br>One dead tree is close to one of the cut through paths. | Fell dead Alder tree to ground level, marked with ORANGE paint | 6 Months | <br>Dead tree | |
